TECHNICAL BULLETIN

INSTALLATION ADVICE

Brake discs with ABS rings and sensors:

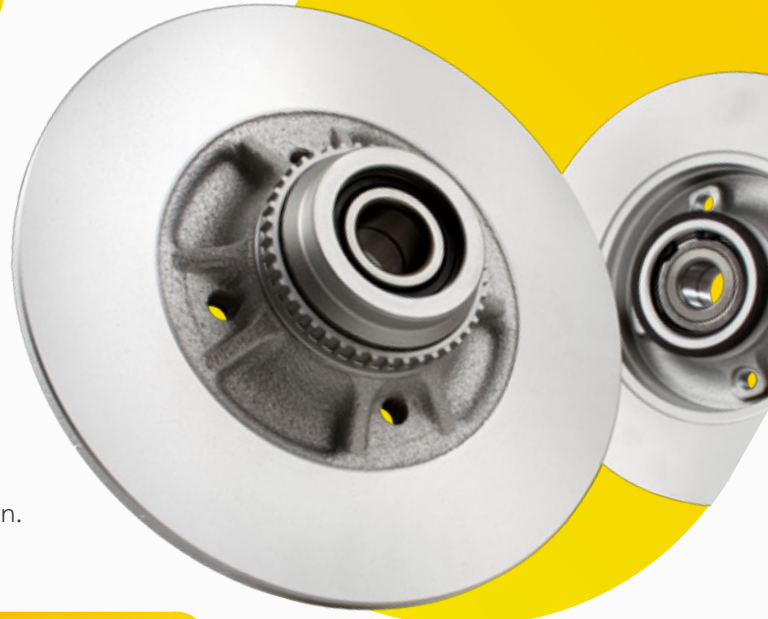
It may be possible to visually identify this problem prior to disassembly but there are some other symptoms to watch out for. The first is potential problems with the ABS system when fitting the new disc. Quite simply, if the ring and sensor are in direct contact, they will not function as intended or communicate with the vehicle's ABS system. In addition, the mis-located ABS sensor on the mounting point may have caused visible damage to the ABS ring on the disc being replaced. The image above illustrates the typical damage you should expect to see.

When correctly installed there is a defined 'air gap' between the ABS ring on the disc and the ABS sensor mounted to the vehicle. However, corrosion build-up on and around the mounting point can push the ABS sensor out of place. When installing a new disc, this removes the air gap and causes ABS ring and ABS sensor to touch.

- Remove the ABS sensor from the vehicle.
- Remove any corrosion from the sensor mounting point. If the sensor is installed within a guide tube, remove the sensor from the tube and remove any corrosion that is present.
- Check the ABS sensor for damage and replace if required. The original sensor can be safely re-installed if there are no visible signs of damage.
- Install the new brake disc ensuring correct air gap between ABS sensor and ABS ring.
- Check to ensure proper function of vehicle ABS system.
