ENGINE MANAGEMENT

MOTAQUIP TEC TALK

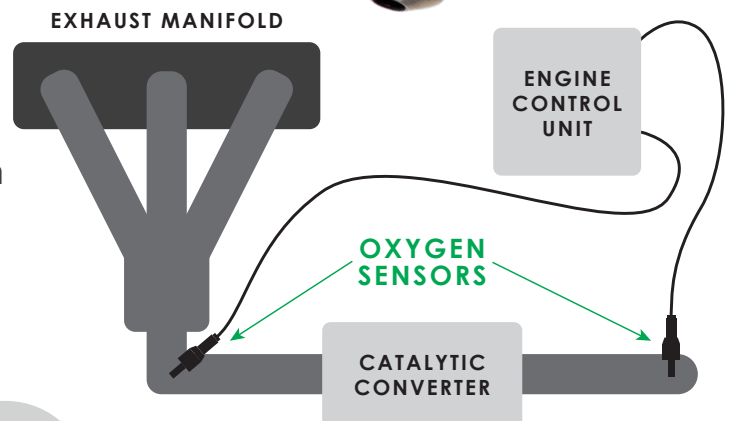
COMMON FAILURE CAUSES

Contamination

Heater Element Failure Due To High Temperature Exposure

Electrical Issues

- Diagnostic code reader to obtain fault codes.
- Check the resistance of the internal heater.
- Check the power supply to the heater.
- Check the condition of the probe element protective tube for signs of damage and contamination.
- Inspect the electrical connector for damage and dirt.
